# **AUDI RANGE DRIVERS INFORMATION SYSTEM** **REPAIR**

## **Overview**

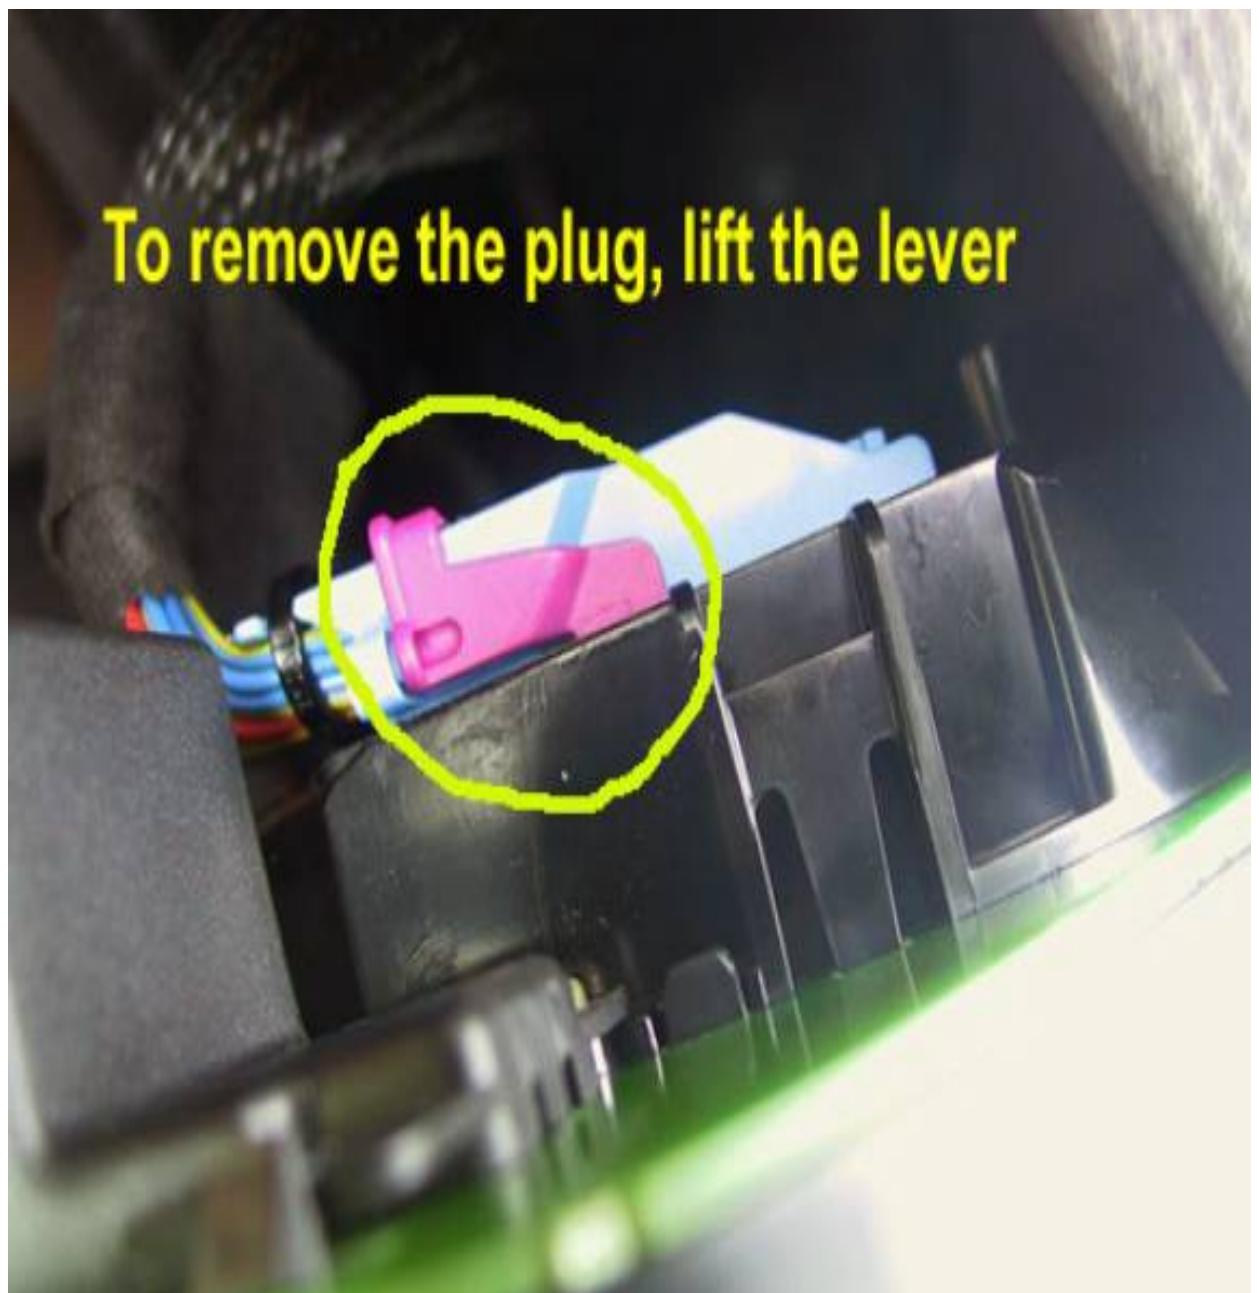
**Next, disconnect all the rear plugs noting that you must pull up the securing lever on each one before pulling them away.**

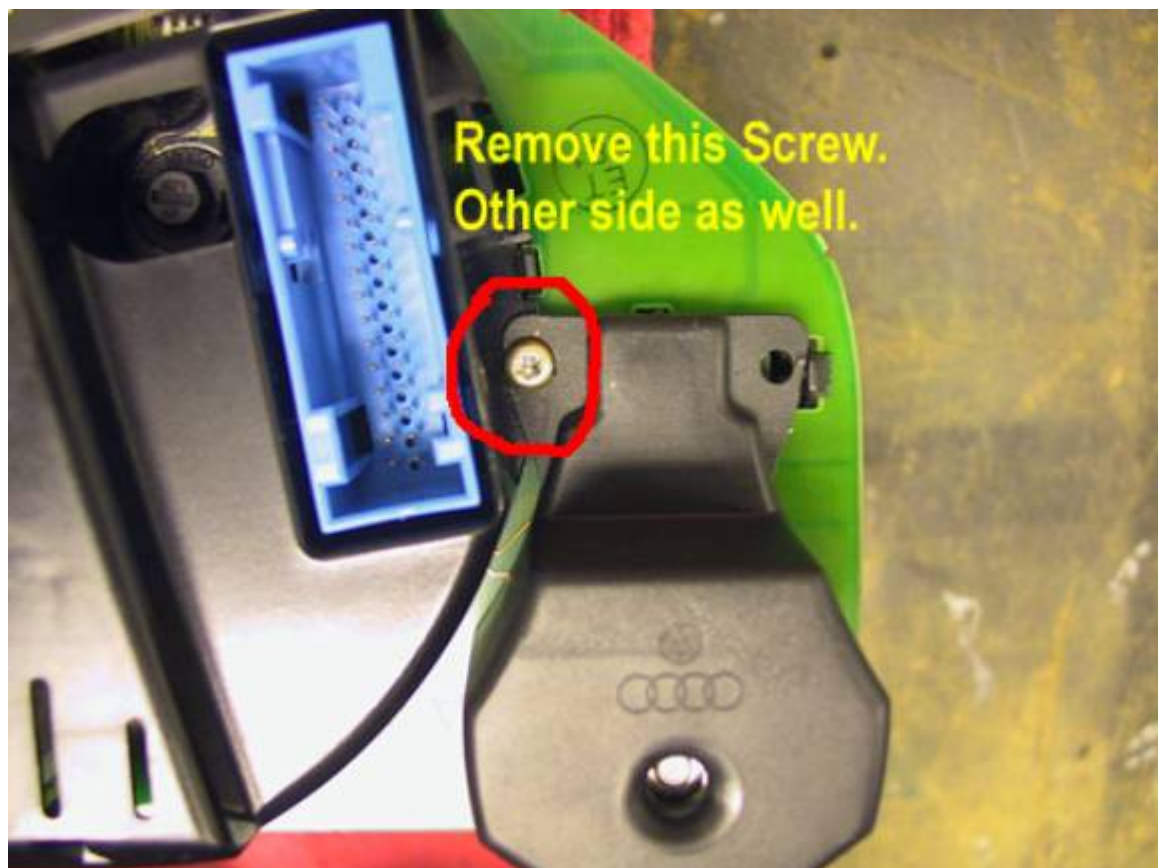
**Place the removed cluster face down on a towel and remove the cover. Take out the screws and snap open the cover; on newer models of Audi, you will have two screws holding the back in place as well as the tabs.**
